**Flood Control Project Maintenance
Levee Inspections**
LMA District Cover Sheet
Spring 2018 Levee Inspection Results

Reclamation District No. 0003 Grand Island

Spring 2018 Levee Inspection Results

| Waterway | | | Bank | Unit Miles |
|--|---|---|---|---|
| Unit No. 01 Left Bank Steamboat Slough | | | Left | 10.95 |

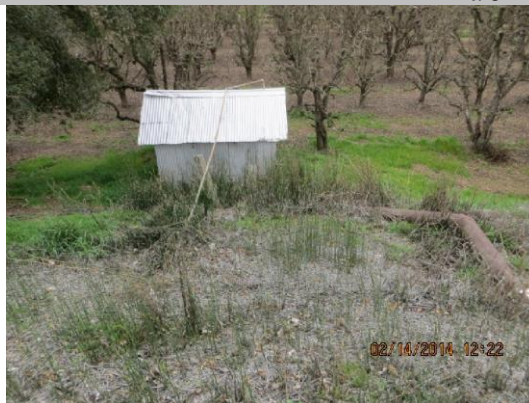
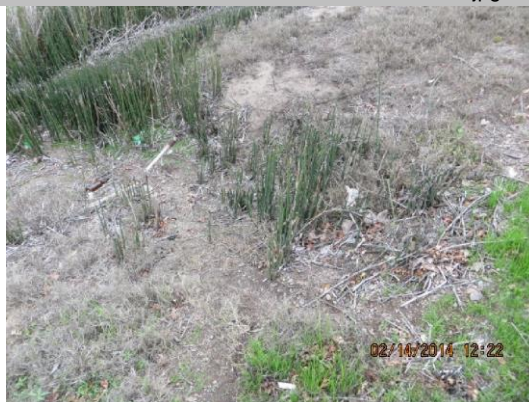
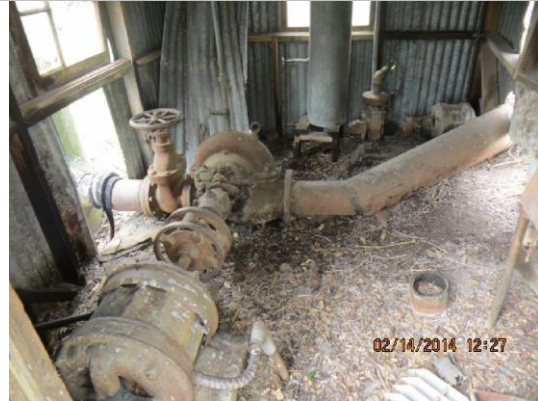
| FS_ID:30164 DS_ID:22370 EP_NO: N/A Repair Type: Non-Urgent Crossing Status: Indicator Found UCIP Comments: Pipe abandoned and should be verified as having been done so properly. FIELD_STRUCT_DESC: *ABANDONED* 7-inch steel pipe of an unknown purpose through the levee, invert elevation 4.6 feet below the crown. (Green). 1.5-inch electrical conduit through the levee at the same location. Depression in-line with pump house on the waterside (WS) is a good indicator of the pipe location. 36-inch concrete standpipe at the landside (LS) toe. [DWR Levee Log, 1993. USACE Sacramento O&M Manual 104, February 1960, (RM 29.94)]. FS Date: 2/14/2014 | | | | | |

Pumphouse on LS toe good indicator of abandoned pipe location.

Depression on WS slope and electrical conduit at approximate location of pipe.

Original pump now used for 10-inch.

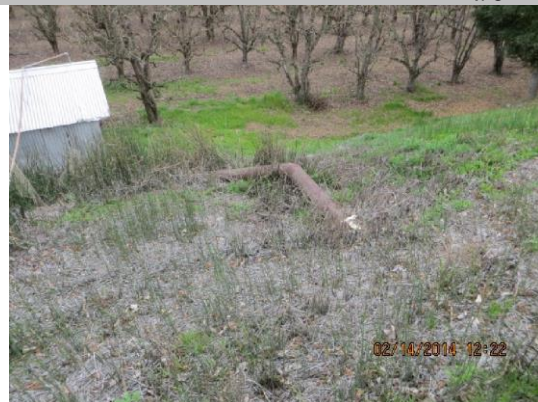
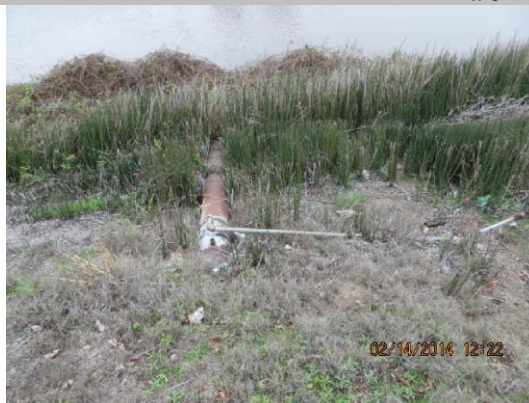
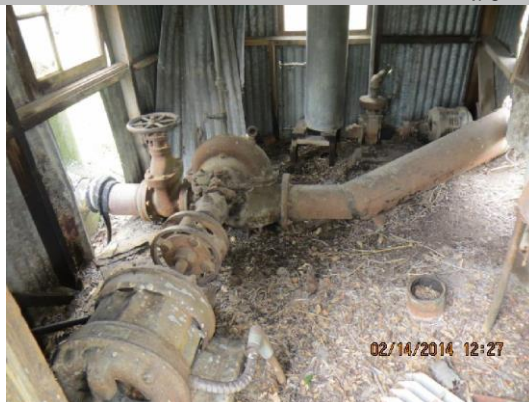
| FS_ID:30165 DS_ID:22369 EP_NO: 919 Repair Type: Non-Urgent Crossing Status: Found UCIP Comments: Appears abandoned and if so should be done so properly. FIELD_STRUCT_DESC: 10-inch steel irrigation discharge pipe through the levee, invert elevation 3.8 feet below the crown. Pump and gate valve in a pump house at the landside (LS) toe. 2-inch filler pipe at the same location, 3 feet below the crown. (Plans for the installation of a 10-inch, 7-gauge welded steel pipe through the levee authorized under Permit No. 919, 1943 - Dell Kercheval). [Additional Reference(s): DWR Levee Log, 1993. USACE Sacramento O&M Manual 104, February 1960 (RM 29.94)]. FS Date: 2/14/2014 | | | | | | |

Pipe visible on LS slope.

Pipe visible on WS slope and filler pipe visible.

Pump and gate valve visible in pumphouse. Connection to concrete standpipe failing.

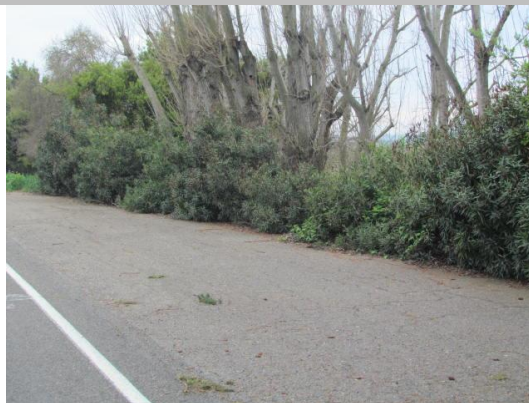
Looking southeast at dense landscape on landward slope.

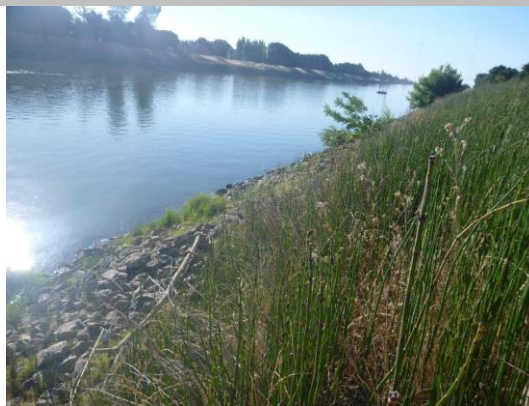
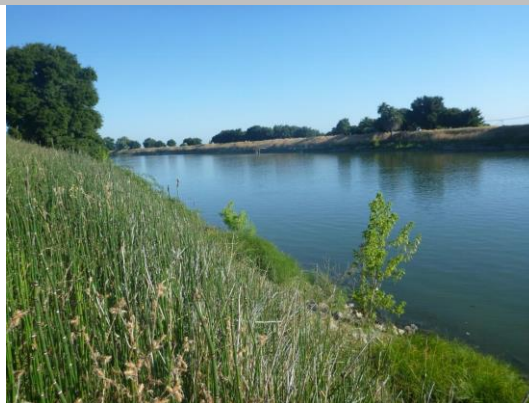
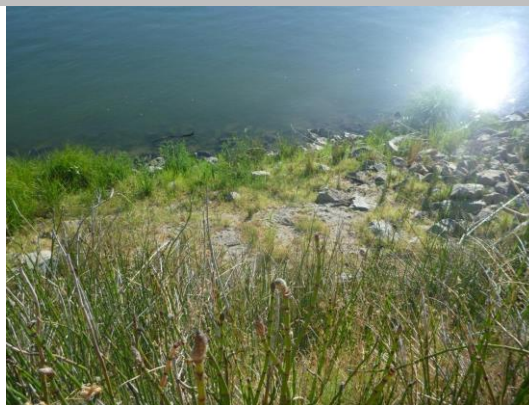
| Repair Type: Erosion | | | | | |
| Notes: no berm | | | | | |

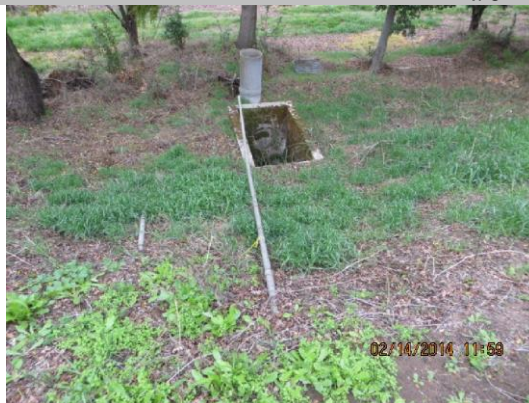
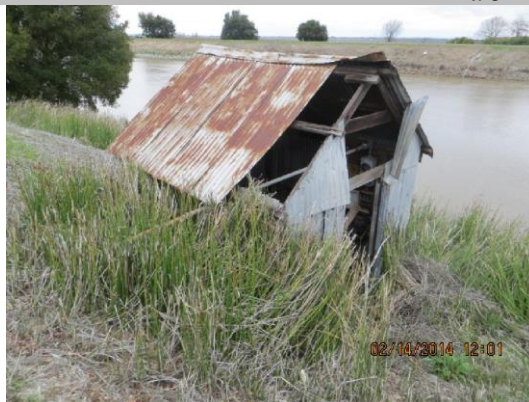
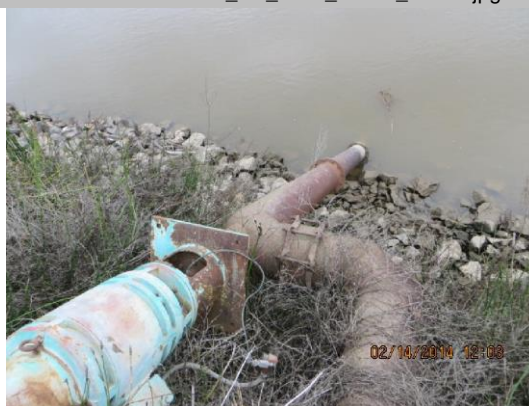
FS_ID:50429
DS_ID:22371
EP_NO: N/A
Repair Type: Urgent
Crossing Status: Found
UCIP Comments: 07/06/2016 Heavy vegetation prevented visibility. Per RD0003 president David Robertson, WS erosion repaired last Spring. Could not fully see any repair work done. Need to return when vegetation cleared. Appears abandoned and if so should be done properly. (DWR UCIP - K. Fazel)02/14/2014 Pipe rusted through on WS slope. Appears abandoned and should be done so properly. Erosion of WS slope under pipe on WS toe. (DWR FPIB - G. Wylie)
FIELD_STRUCT_DESC: *ABANDONED* 12-inch steel irrigation discharge pipe through the levee, invert elevation 7 feet below the crown. Slant pump next to old pump house on the waterside (WS) slope. 2-inch filler pipe at the same location. 4-foot by 8-foot concrete distribution box and standpipe at the landside (LS) toe. (Plans to replace a 12-inch steel pipe through the levee authorized under Permit No. 7082, 1974 - Pacific Fruit Farms). Permit was canceled. Original pipe remains. [Additional Reference(s): DWR Levee Log, 1993. USACE Sacramento O&M Manual 104, February 1960, (RM 30.30)].

Concrete distribution box on LS toe with electrical conduit visible.

Pumphouse on WS slope next to slant pump.

Slant pump on WS slope.

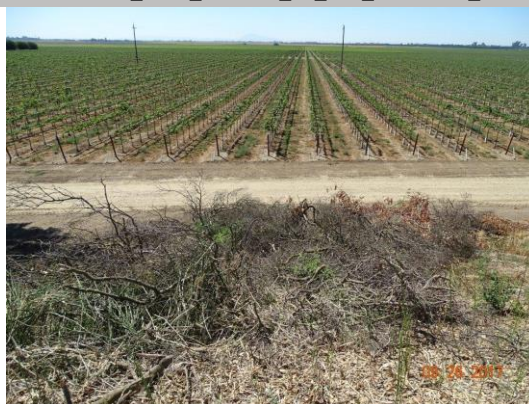
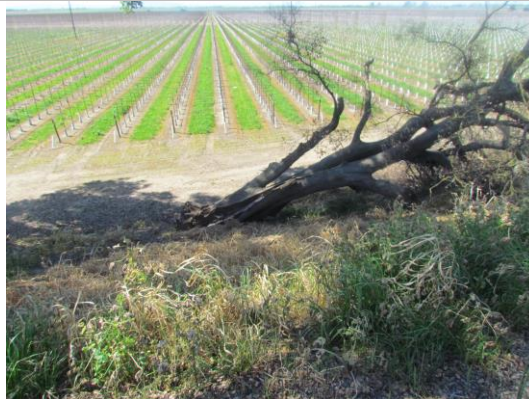
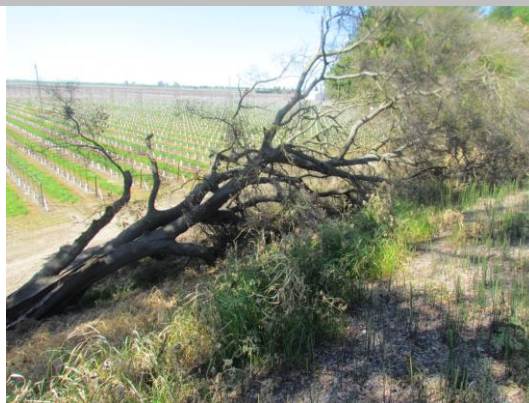
| Large fallen tree on landside slope. Large tree removed, prunings remain on slope. | | | | | |

Looking southwest at the landside slope.

Looking west at fallen tree at landward toe.

Looking northwest at fallen tree at landward toe.

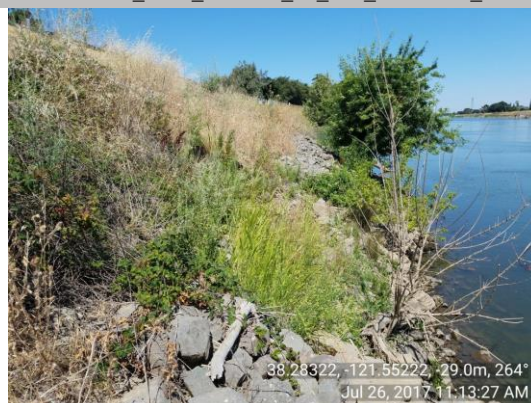
Photo 1 of 3 : SP_2018_RD0003_25_149_20180305_00124.jpg

| Repair Type: Erosion | | | | | |

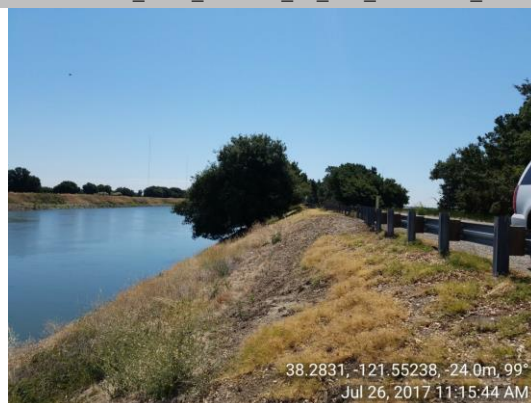
Photo 3 of 3 : SP_2018_RD0003_25_149_20180305_00126.jpg

38.2831, -121.55238, -24.0m, 99°
Jul 26, 2017 11:15:44 AM

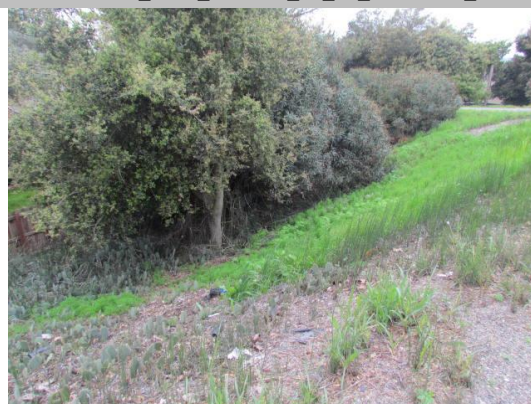
Photo 1 of 1 : SP_2018_RD0003_25_94_20180305_00080.jpg

| Dense landscaping on landside slope and toe. | | | | | |

Looking northwest at landscape at landward toe.

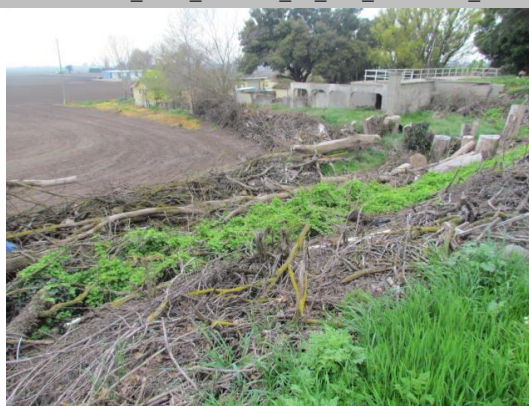
Photo 2 of 2 : SP_2018_RD0003_25_144_20180305_00120.jpg

| Prunings piled on landside slope and toe along with tree stumps. | | | | | | |

Looking southwest at prunings on landward slope and toe. (Spring 2016)

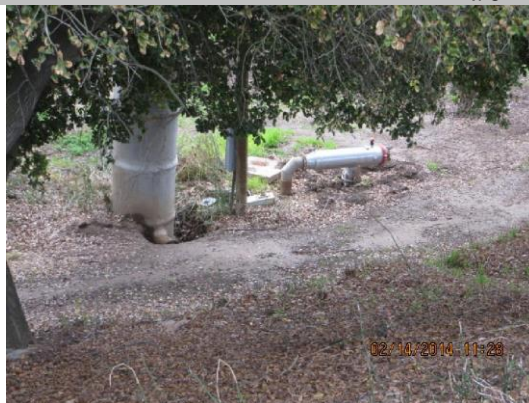
Photo 1 of 3 : UCIP_SP_2018_30084_55485.jpg

| FS_ID:30084 DS_ID:22334 EP_NO: 2137 Repair Type: Non-Urgent Crossing Status: Found UCIP Comments: Appears abandoned and if so should be done so properly. Leak apparent at pipe connection to concrete standpipe at LS toe. Good candidate for video inspection. FIELD_STRUCT_DESC: 12-inch steel irrigation discharge pipe through the levee, invert elevation 9 feet below the crown. Slant pump on the waterside (WS) slope. 44-inch concrete standpipe at the landside (LS) toe. 1.5-inch electrical conduit through the levee at the same location. Filter plant at the LS toe. (Plans for the installation of a 12-inch irrigation pipe through the levee authorized under Permit No. 2137, 1955 - Pacific Fruit Exchange). [Additional Reference(s): DWR Levee Log, 1993, 14-inch pipe referenced, 6.5 feet below the crown. USACE Sacramento O&M Manual 104, February 1960, (RM 30.76)]. FS Date: 2/14/2014 | | | | | | |

Concrete standpipe, filter plant, power pole and meter on LS toe.

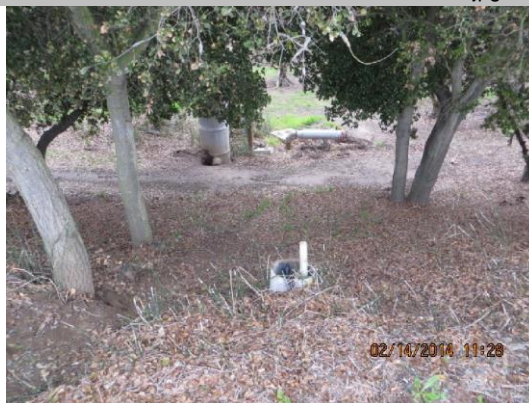
Photo 2 of 3 : UCIP_SP_2018_30084_55484.jpg

Siphon breaker on LS shoulder.

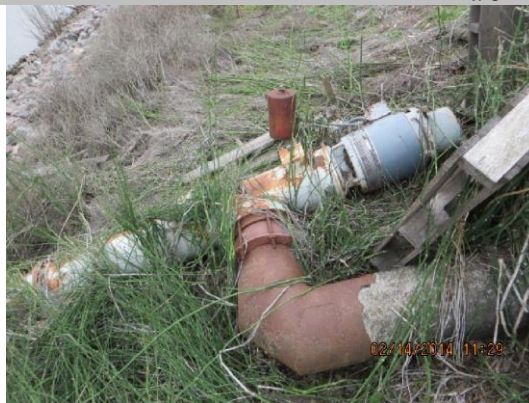
Photo 3 of 3 : UCIP_SP_2018_30084_55483.jpg

| FS_ID:30084 DS_ID:22334 EP_NO: 2137 Repair Type: Non-Urgent Crossing Status: Found UCIP Comments: Appears abandoned and if so should be done so properly. Leak apparent at pipe connection to concrete standpipe at LS toe. Good candidate for video inspection. FIELD_STRUCT_DESC: 12-inch steel irrigation discharge pipe through the levee, invert elevation 9 feet below the crown. Slant pump on the waterside (WS) slope. 44-inch concrete standpipe at the landside (LS) toe. 1.5-inch electrical conduit through the levee at the same location. Filter plant at the LS toe. (Plans for the installation of a 12-inch irrigation pipe through the levee authorized under Permit No. 2137, 1955 - Pacific Fruit Exchange). [Additional Reference(s): DWR Levee Log, 1993, 14-inch pipe referenced, 6.5 feet below the crown. USACE Sacramento O&M Manual 104, February 1960, (RM 30.76)]. FS Date: 2/14/2014 | | | | | | |

Slant pump on WS slope.

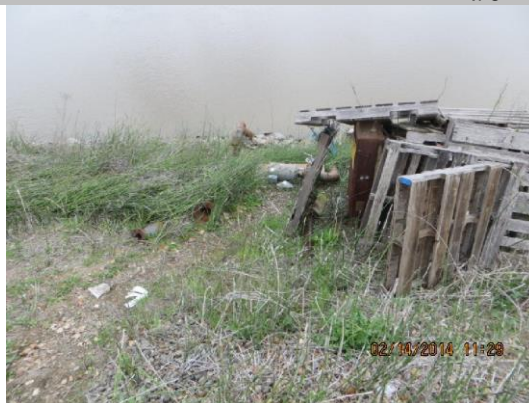
Photo 1 of 3 : UCIP_SP_2018_30083_55482.jpg

| FS_ID:30083 DS_ID:22375 EP_NO: 7356 Repair Type: Non-Urgent Crossing Status: Found UCIP Comments: Pipe debris on WS slope. FIELD_STRUCT_DESC: 10-inch steel irrigation discharge pipe through the levee, 6.5 feet below the crown. 8-inch pipe on the landside (LS) slope. 6-inch pipe on the waterside (WS) slope. Pump and gate valve on the WS slope. (Plans to install a 6-inch pipe and pump on the WS slope of the levee authorized under Permit No. 7356, 1971 - Pacific Fruit Farms. USACE, Unit No. 15, 1969). [Additional Reference(s): DWR Levee Log, 1993]. FS Date: 2/14/2014 | | | | | | |

Pump on WS slope next to slant pump.

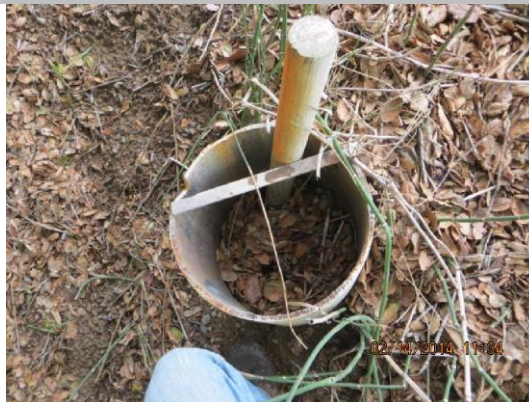
Photo 2 of 3 : UCIP_SP_2018_30083_55481.jpg

Vent or Siphon Breaker in 14-inch steel riser on LS slope.

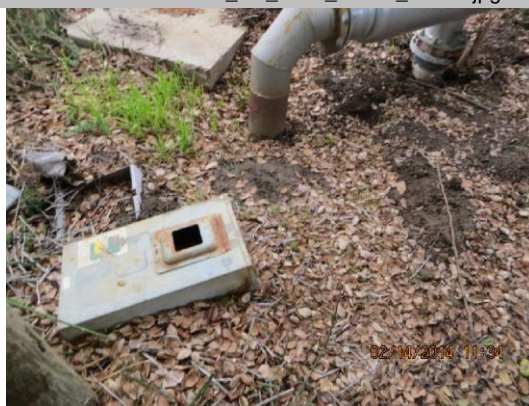
Photo 3 of 3 : UCIP_SP_2018_30083_55480.jpg

| FS_ID:30083 DS_ID:22375 EP_NO: 7356 Repair Type: Non-Urgent Crossing Status: Found UCIP Comments: Pipe debris on WS slope. FIELD_STRUCT_DESC: 10-inch steel irrigation discharge pipe through the levee, 6.5 feet below the crown. 8-inch pipe on the landside (LS) slope. 6-inch pipe on the waterside (WS) slope. Pump and gate valve on the WS slope. (Plans to install a 6-inch pipe and pump on the WS slope of the levee authorized under Permit No. 7356, 1971 - Pacific Fruit Farms. USACE, Unit No. 15, 1969). [Additional Reference(s): DWR Levee Log, 1993]. FS Date: 2/14/2014 | | | | | | |

Pipe and filter plant on LS toe.

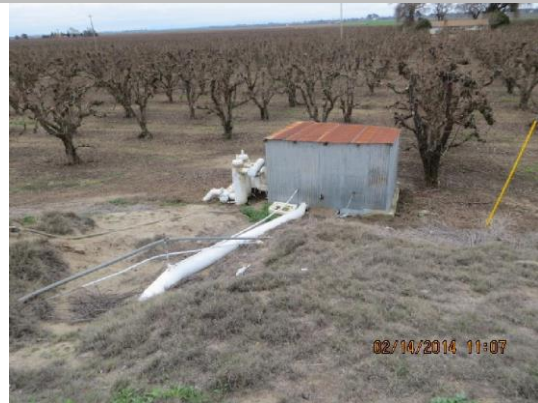
Photo 1 of 3 : UCIP_SP_2018_30004_55382.jpg

| FS_ID:30004 DS_ID:22376 EP_NO: 17382 Repair Type: Non-Urgent Crossing Status: Found UCIP Comments: Tank on LS slope not listed in permit. FIELD_STRUCT_DESC: 12-inch steel irrigation discharge pipe through the levee, 10 feet below the crown. Pump and butterfly valve in a pump house at the landside (LS) toe. Siphon breaker on the waterside (WS) slope. Tank on the LS slope. (Plans to abandon in place two existing deteriorated pipes and install a 12-inch steel irrigation pipe and a 2-inch steel irrigation pipe through the crown and on the slopes of the levee authorized under Permit No. 17382, 2001 - Ferreira Estate Company, DCC Engineering Company, Inc). [Additional Reference(s): DWR Levee Log, 1993, referenced as 5.2 feet below the crown]. FS Date: 2/14/2014 | | | | | | |

Pump in pumphouse on LS toe.

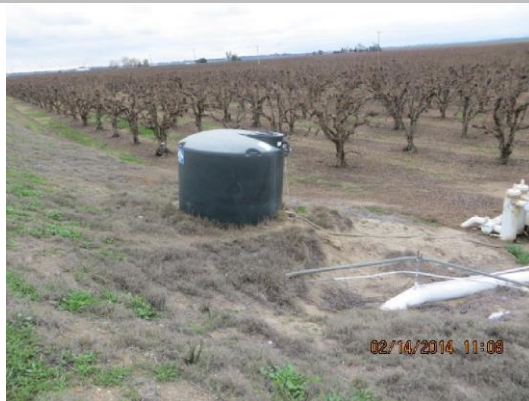
Photo 2 of 3 : UCIP_SP_2018_30004_55381.jpg

| FS_ID:30004 DS_ID:22376 EP_NO: 17382 Repair Type: Non-Urgent Crossing Status: Found UCIP Comments: Tank on LS slope not listed in permit. FIELD_STRUCT_DESC: 12-inch steel irrigation discharge pipe through the levee, 10 feet below the crown. Pump and butterfly valve in a pump house at the landside (LS) toe. Siphon breaker on the waterside (WS) slope. Tank on the LS slope. (Plans to abandon in place two existing deteriorated pipes and install a 12-inch steel irrigation pipe and a 2-inch steel irrigation pipe through the crown and on the slopes of the levee authorized under Permit No. 17382, 2001 - Ferreira Estate Company, DCC Engineering Company, Inc). [Additional Reference(s): DWR Levee Log, 1993, referenced as 5.2 feet below the crown]. FS Date: 2/14/2014 | | | | | |

Tank on LS slope not noted in permit.

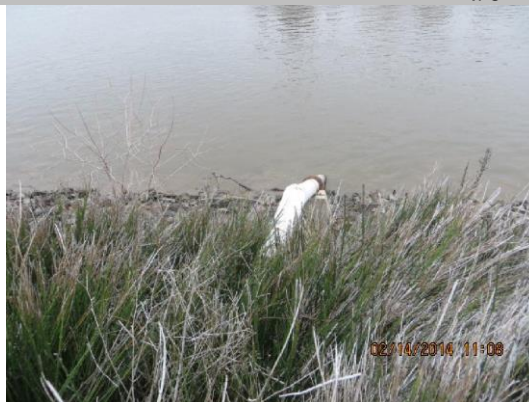
Photo 3 of 3 : UCIP_SP_2018_30004_55380.jpg

Pipe visible on WS slope.

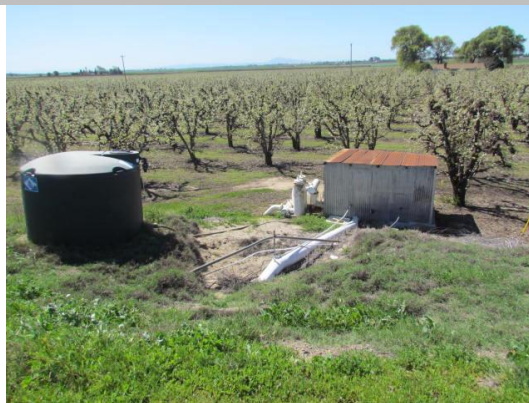
Photo 1 of 2 : SP_2018_RD0003_25_75_20180305_00058.jpg

| Tank is located next to irrigation system on landside slope. No permit for this tank was found. | | | | | |

Looking west at tank next to pump house on landward slope.

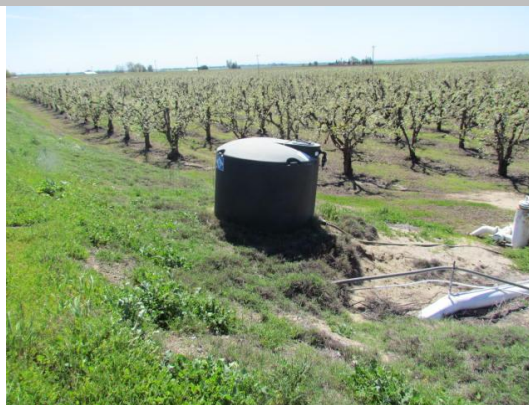
Photo 2 of 2 : SP_2018_RD0003_25_75_20180305_00059.jpg

Looking southwest at tank on landside slope.

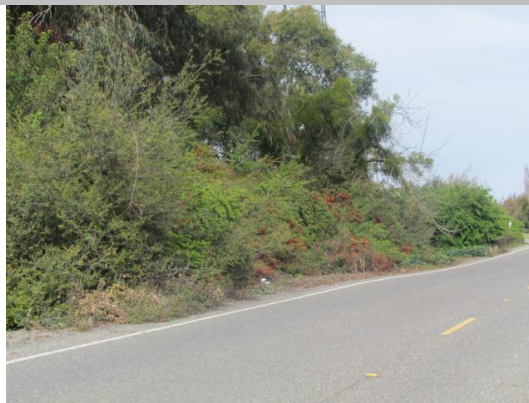
Photo 1 of 1 : SP_2018_RD0003_25_60_20180305_00049.jpg

Looking west at dense landscaping on landside shoulder and slope.

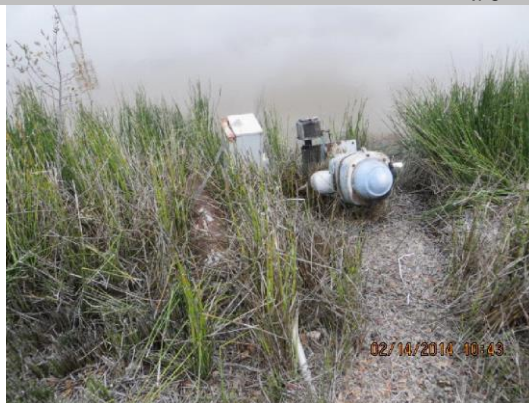
Photo 1 of 3 : UCIP_SP_2018_29986_55369.jpg

| FS_ID:29986 DS_ID:22378 EP_NO: N/A Repair Type: Non-Urgent Crossing Status: Found UCIP Comments: siphon breaker on LS slope should have CMP riser protection. FIELD_STRUCT_DESC: 16-inch steel irrigation discharge pipe through the levee, 8 feet below the crown. Slant pump on the waterside (WS) slope. Siphon breaker on the landside (LS) slope. 44-inch concrete standpipe at the LS toe. 2-inch aluminum electrical conduit through the levee at the same location as the pipe. (T. Ferreira. USACE Unit No. 6, 1967). [Additional Reference(s): DWR Levee Log, 1993, referenced as 15 feet below the crown. USACE Sacramento O&M Manual 104, February 1960, (RM 31.39), 12-inch pipe, invert elevation 15 feet below the crown, referenced]. FS Date: 2/14/2014 | | | | | |

Slant pump and electrical conduit on WS slope.

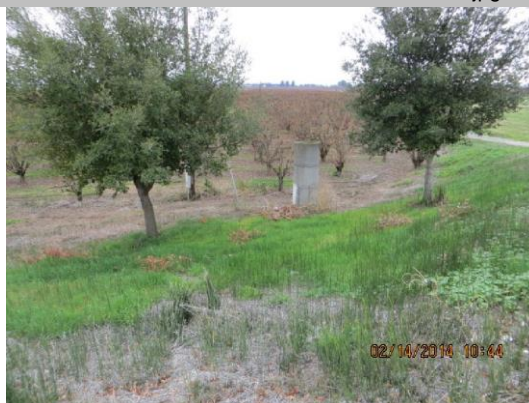
Photo 2 of 3 : UCIP_SP_2018_29986_55368.jpg

44-inch concrete standpipe on LS toe.

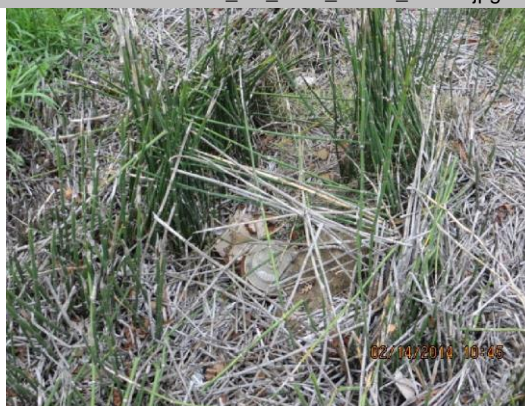
Photo 3 of 3 : UCIP_SP_2018_29986_55367.jpg

| FS_ID:29986 DS_ID:22378 EP_NO: N/A Repair Type: Non-Urgent Crossing Status: Found UCIP Comments: siphon breaker on LS slope should have CMP riser protection. FIELD_STRUCT_DESC: 16-inch steel irrigation discharge pipe through the levee, 8 feet below the crown. Slant pump on the waterside (WS) slope. Siphon breaker on the landside (LS) slope. 44-inch concrete standpipe at the LS toe. 2-inch aluminum electrical conduit through the levee at the same location as the pipe. (T. Ferreira. USACE Unit No. 6, 1967). [Additional Reference(s): DWR Levee Log, 1993, referenced as 15 feet below the crown. USACE Sacramento O&M Manual 104, February 1960, (RM 31.39), 12-inch pipe, invert elevation 15 feet below the crown, referenced]. FS Date: 2/14/2014 | | | | | | |

Siphon breaker on LS slope

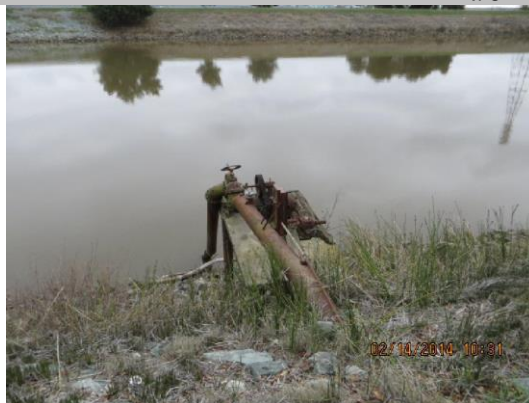
Photo 1 of 3 : UCIP_SP_2018_50190_55362.jpg

FS_ID:50190
DS_ID:22380
EP_NO: 1075
Repair Type: Urgent
Crossing Status: Found
UCIP Comments: 07/06/2016 Same as last inspection. Pipe to be replaced soon via CVFPB permit. (DWR UCIP - kfazel)02/14/2014
Apparent sinkhole over pipe at crown. Appears abandoned and should be done so properly. (DWR UCIP - pamatya)
FIELD_STRUCT_DESC: *ABANDONED* 10-inch (not 12-inch as mentioned in the desk study) steel irrigation discharge pipe through the levee, invert elevation 3.7 feet below the crown. Pump and gate valve on a pier on the waterside (WS) slope. 44-inch concrete standpipe at the landside (LS) toe. 1.5-inch electrical conduit through the levee at the same location. (Plans for installation of a pumping plant with a 12-inch discharge line through the levee authorized under Permit No. 1075, 1945 - R. B. Kercheval). Robert Kercheval, lindakerch@gmail.com, (916) 429-8005, with DCC Engineering Company, Inc, has applied for a replacement CVFPB permit. Contact: Emily Pappalardo, emily@dccengineering.net. [Additional Reference(s): DWR Levee Log, 1993, 12-inch pipe referenced. USACE Sacramento O&M Manual 104, February 1960, (RM 31.52), 8-inch pipe referenced].

Pipe and pump on concrete pad on WS slope.

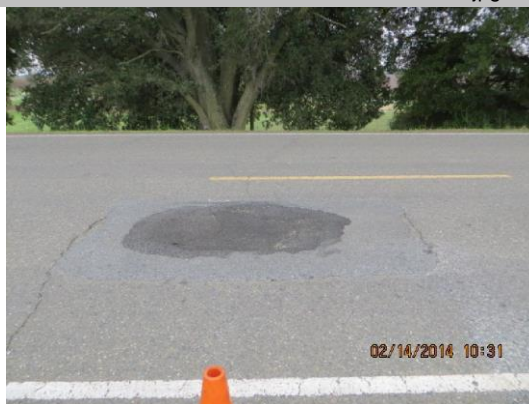
Photo 2 of 3 : UCIP_SP_2018_50190_55361.jpg

Apparent sinkhole over pipe at crown.

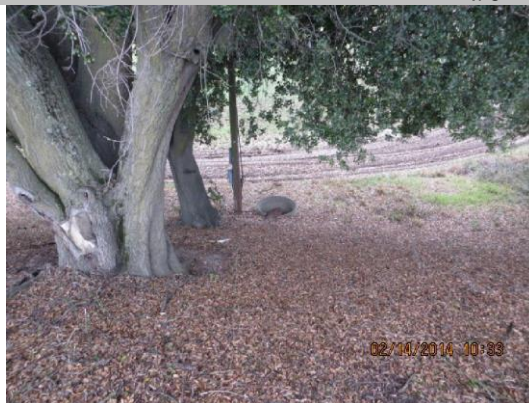
Photo 3 of 3 : UCIP_SP_2018_50190_55360.jpg

| FS_ID:50190 DS_ID:22380 EP_NO: 1075 Repair Type: Urgent Crossing Status: Found UCIP Comments: 07/06/2016 Same as last inspection. Pipe to be replaced soon via CVFPB permit. (DWR UCIP - kfazel)02/14/2014 Apparent sinkhole over pipe at crown. Appears abandoned and should be done so properly. (DWR UCIP - pamatya) FIELD_STRUCT_DESC: *ABANDONED* 10-inch (not 12-inch as mentioned in the desk study) steel irrigation discharge pipe through the levee, invert elevation 3.7 feet below the crown. Pump and gate valve on a pier on the waterside (WS) slope. 44-inch concrete standpipe at the landside (LS) toe. 1.5-inch electrical conduit through the levee at the same location. (Plans for installation of a pumping plant with a 12-inch discharge line through the levee authorized under Permit No. 1075, 1945 - R. B. Kercheval). Robert Kercheval, lindakerch@gmail.com, (916) 429-8005, with DCC Engineering Company, Inc, has applied for a replacement CVFPB permit. Contact: Emily Pappalardo, emily@dccengineering.net. [Additional Reference(s): DWR Levee Log, 1993, 12-inch pipe referenced. USACE Sacramento O&M Manual 104, February 1960, (RM 31.52), 8-inch pipe referenced]. FS Date: 7/6/2016 7:21:00 AM | | | | | |

Concrete standpipe and meter on pole at LS toe.

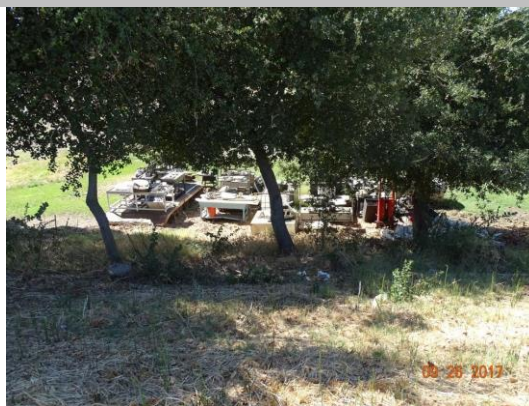
Photo 1 of 2 : SP_2018_RD0003_25_166_20180305_00141.jpg

| Landowner has equipment and wood stored at toe of landside slope. | | | | | |

Looking southwest at the landside slope.

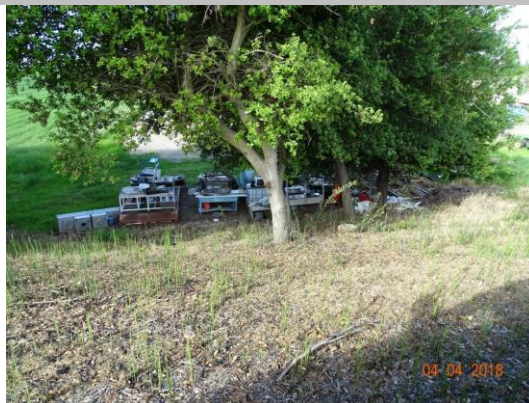
Photo 2 of 2 : SP_2018_RD0003_25_166_20180404_00285.jpg

| Landowner has equipment and wood stored at toe of landside slope. | | | | | | |

Equipment at landside toe.

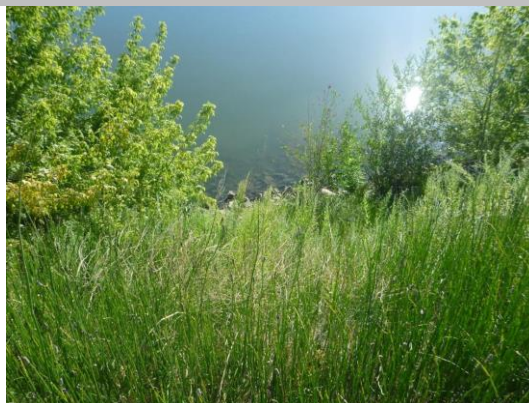
Photo 1 of 2 : SP_2018_RD0003_25_150_20180305_00127.jpg

| Notes: no berm | | | | | |

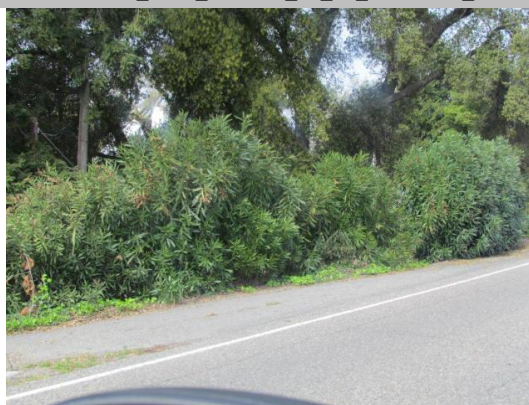
Photo 1 of 4 : SP_2018_RD0003_25_77_20180305_00062.jpg

| Landowner removed oleanders, but other vegetation still blocking view of landside slope and toe. | | | | | |

Looking west at landscaping on landside shoulder and slope. (Fall 2015)

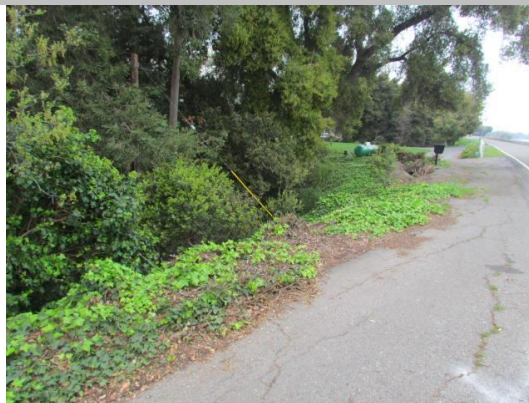
Photo 2 of 4 : SP_2018_RD0003_25_77_20180305_00063.jpg

Looking north at landscape on landward slope and toe. (Spring 2016)

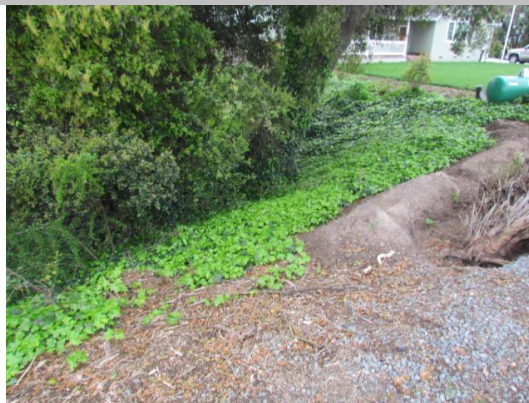
Photo 3 of 4 : SP_2018_RD0003_25_77_20180305_00064.jpg

| Landowner removed oleanders, but other vegetation still blocking view of landside slope and toe. | | | | | | |

Looking north at landscape on landward slope and toe. (Spring 2016)

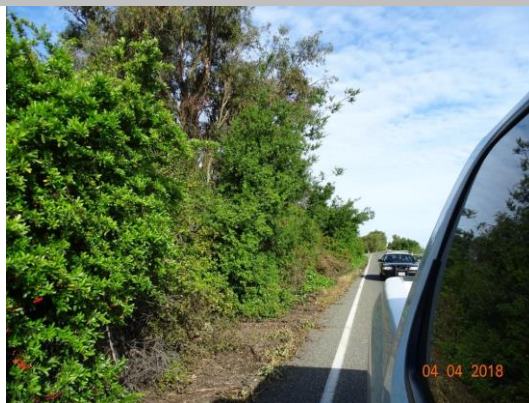
Photo 4 of 4 : SP_2018_RD0003_25_77_20180404_00286.jpg

Dense landside landscaping.

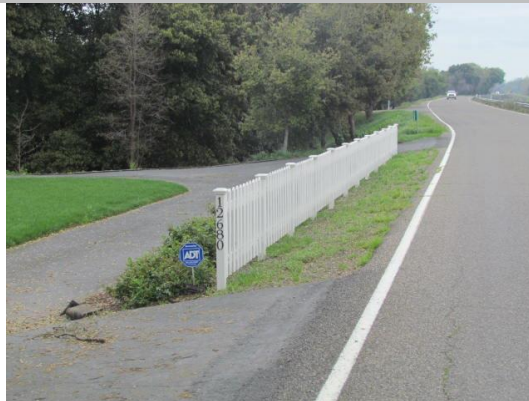
Photo 1 of 2 : SP_2018_RD0003_25_146_20180305_00122.jpg

| Landowner install white fence on landside shoulder. No permit identified for fence. | | | | | |

Looking northeast at new fence on landward slope.

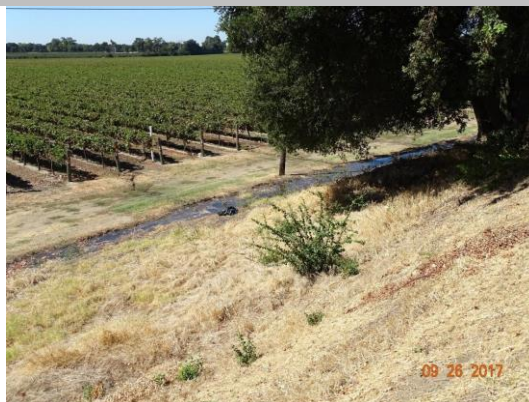
Photo 1 of 1 : SP_2018_RD0003_25_165_20180305_00140.jpg

| Appears landowner has dug a shallow trench along toe of levee to drain water from irrigation. | | | | | |

Looking northwest at the landside slope.

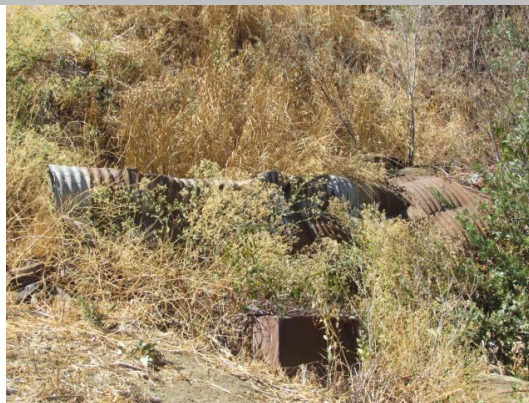
Photo 1 of 1 : SP_2018_RD0003_610_1_20180305_00001.jpg

| Discarded pipe on waterward slope. | | | | | |

Looking at discarded pipe on waterward slope.

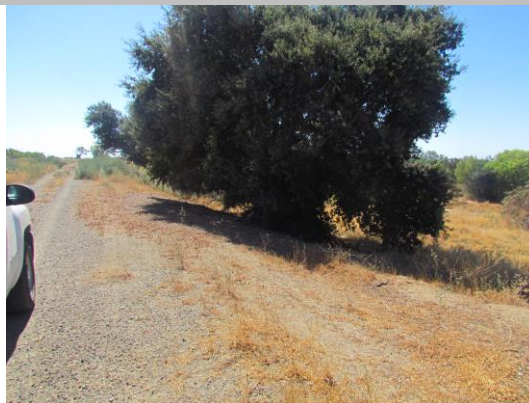
Photo 1 of 1 : SP_2018_RD0003_610_5_20180305_00002.jpg

| Untrimmed trees on waterward slope. | | | | | |

Looking southeast at untrimmed trees on waterward slope and toe.

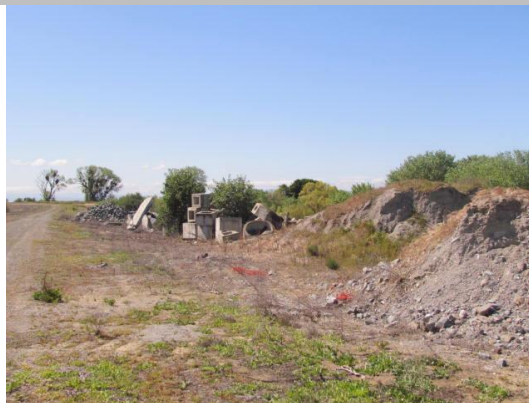
Photo 1 of 1 : SP_2018_RD0003_610_6_20180305_00003.jpg

| Stockpile of concrete rubble and sandpile on waterward slope. | | | | | |

Looking east at concrete rubble and other material stored on landward shoulder and slope.
